REPORT 06MAAD02839 Pt.1

TITLE: Protect-it 100A Plastic Column Guard

SAMPLE IDENTIFICATION: Dexion 90M Steel Upright (1.9mm W.T)

WORK REQUESTED: Witness and supervise testing of the Protect-it 100A plastic column guard whilst attached to a Dexion 90M Steel Upright

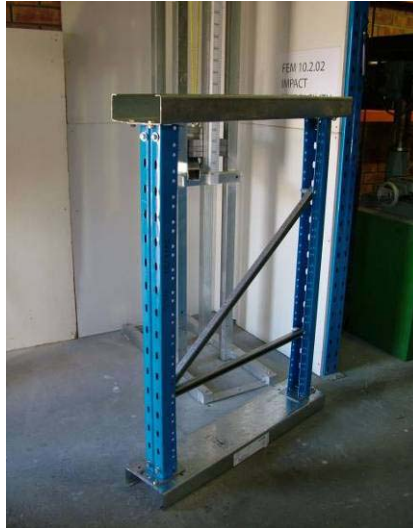
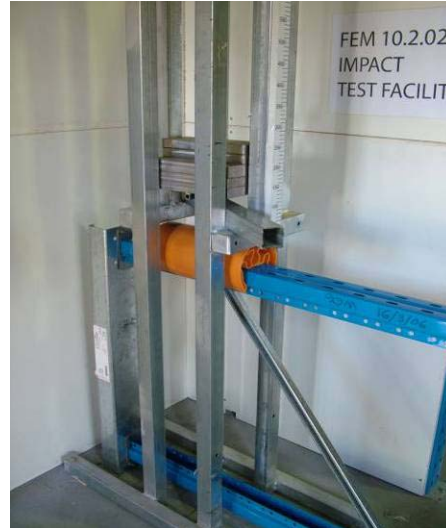
- 6.1 The test jig consists of
- 6.1.1 A vertical frame
- 6.1.2 An impact device weighing 40kg (88.185 pounds) and having a stress concentrator on the impact face that is designed to represent the front edge of a fork tine.
- 6.1.3 The column assembly and base plates under test are assembled to two lengths on 200mm (7.8 inches) wide "C" section. Per the image shown.
- 6.1.4 The weight is raised 1.02 metres (40.16 inches) above the impact surface and released to impact the target zone.

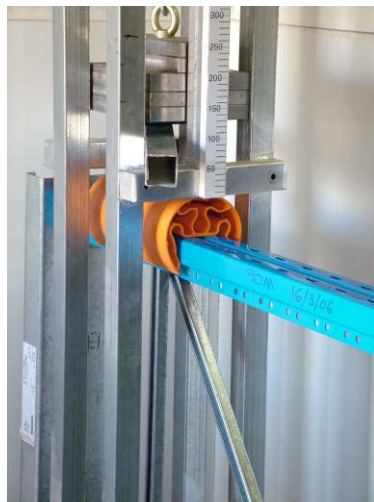
Front Impact

- 7.1 The column assembly is inserted into the test jig and positioned so that impact will occur at the front of the column, 300mm (11.81 inches) above the column base.
- 7.2 The impact device is raised to a height that will apply an impact energy of 400Nm (3540 pound-force-inches) to the column and released
- 7.3 The column assembly is then removed from the jig and inspected for damage
- 7.4 Any protection devices are then removed to allow inspection of the impacted column.
- 7.5 A front impact and side impact test was conducted as shown below

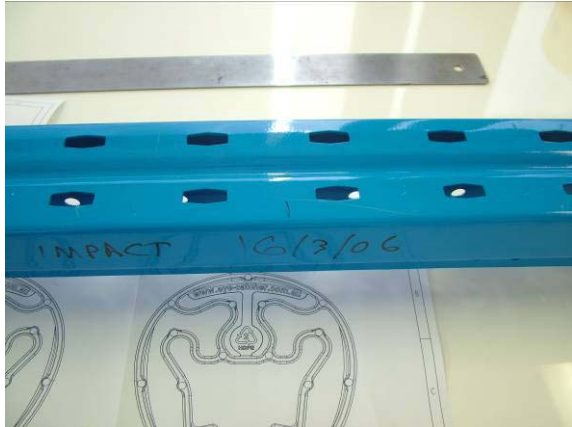
FRONT IMPACT	
Test 1	Test 2
With 3 Protect-its installed	No Protection
<p>Photo of impacted steel section</p>

<p style="text-align: center;">No visible damage Nil Deflection- PASS</p>	<p>Photo of impacted steel section</p>

- 1.1. Protect-it passes the FRONT Impact test when tested on a Dexion 90M upright (1.9mm W.T.)
- 1.2. Protect-it passes the SIDE impact test when tested on a Dexion 90M upright (1.9mm W.T.)
- 1.3. Without Protect-it guards installed, damage to the upright was evident.
- 1.4. Additional protection is recommended at gangway intersections or aisle corners.

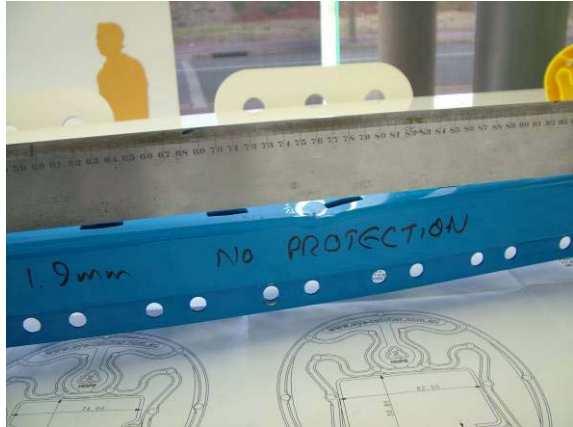
<p style="text-align: center;">Visible damage 10 mm (0.393 inches) Deflection - FAIL</p>

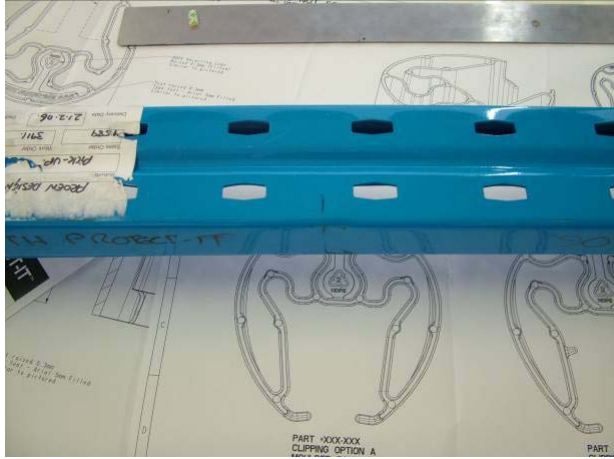
SIDE IMPACT	
Test 1	Test 2
With 3 Protect-it's installed	No Protection
<p>Photo of impacted steel section</p>

<p style="text-align: center;">No Damage- some paint scratching Nil Deflection - Pass</p>	<p>Photo of impacted steel section</p>

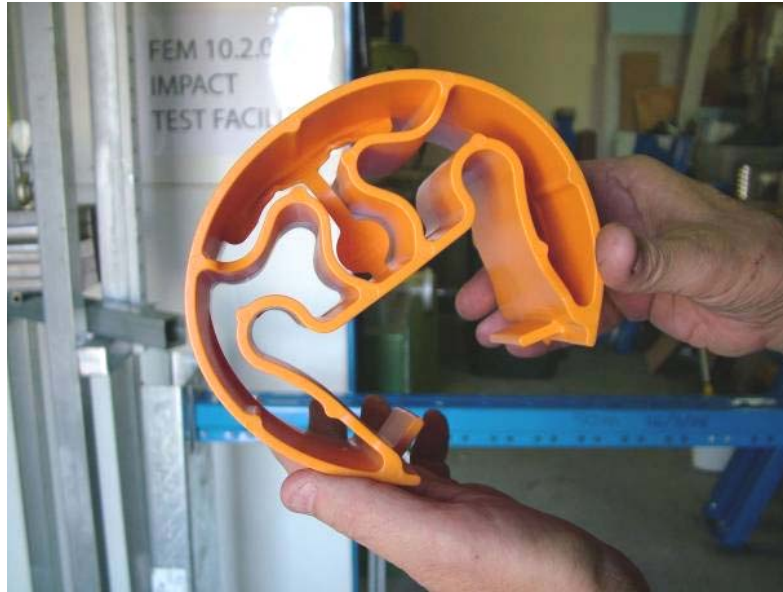
9 Image of an impacted Protect-it Column Guard
